Bonding Lexan and Sapphire to Form High-Pressure, Flame- Resistant Window

William R. Richardson and Ernie D. Walker
Lewis Research Center
Cleveland, Ohio

Prepared for the
129th Technical Conference and Equipment Exhibit
sponsored by the Society of Motion Picture and Television Engineers
Los Angeles, California, October 31—November 4, 1987

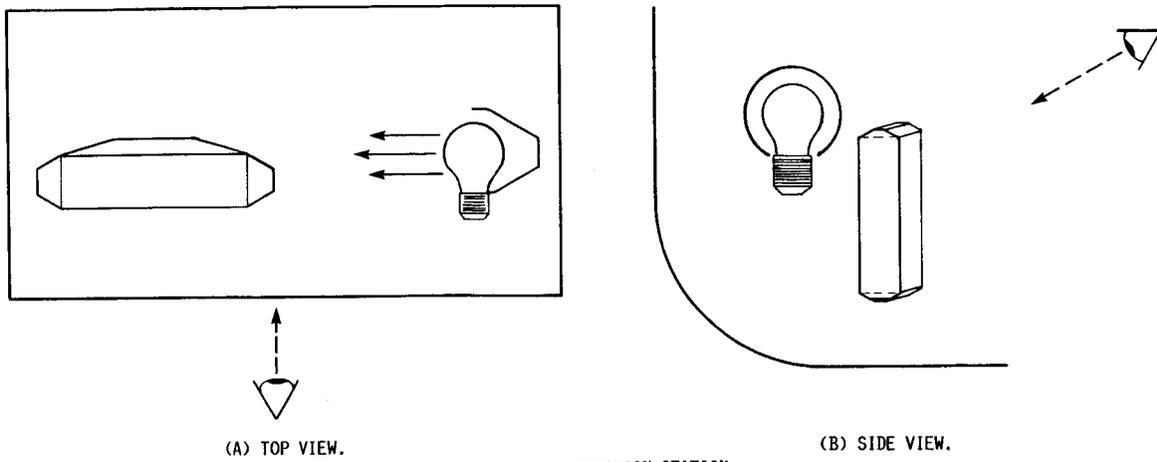
FIGURE 1. - INSPECTION STATION.

After cleaning, each window was visually inspected and any imperfections in either the Lexan or the sapphire were documented. An inspection station was made with a black background and illuminated with a strong, directional side light (fig. 1). This inspection station allowed observation of very small defects.

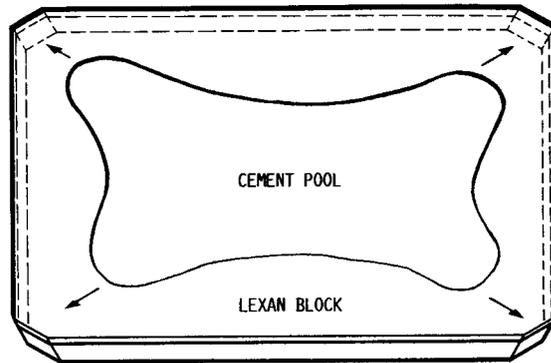
FIGURE 2. - ADHESIVE APPLICATION PATTERN.

The flattest side of the Lexan piece was placed face up on a clean, flat surface. Approximately 15 drops of Norland optical adhesive #68 were applied to the surface in a pattern that had been found to spread evenly (fig. 2). Trapped air bubbles were then removed from the cement, and the cement was allowed to stabilize in order to reduce surface depressions that trap air. The sapphire plate was then lowered onto the surface of the cement, pushing trapped air toward the edges ahead of the contact front (fig. 3). The sapphire plate spread the cement, which formed an oval spot between the surfaces (fig. 4).

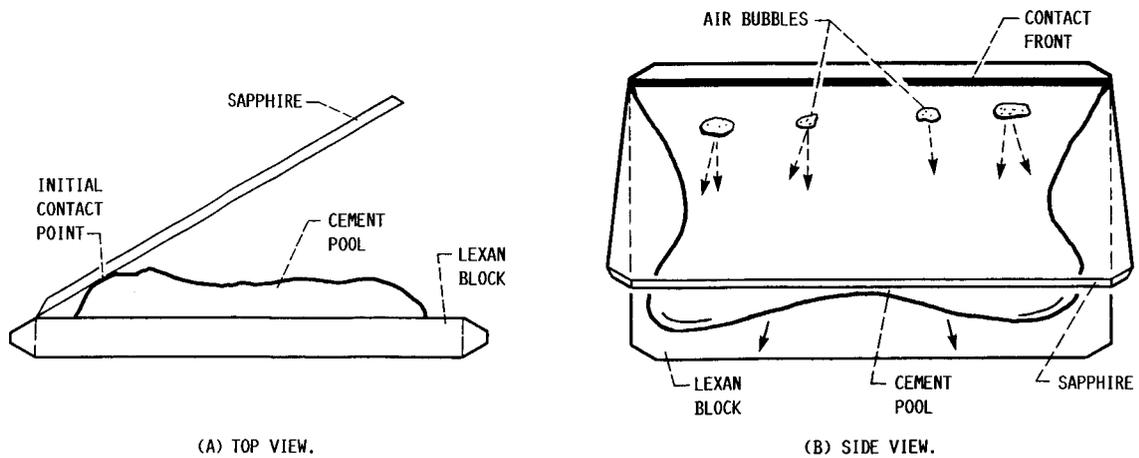
FIGURE 3. - ASSEMBLY OF LEXAN-SAPPHIRE WINDOW.

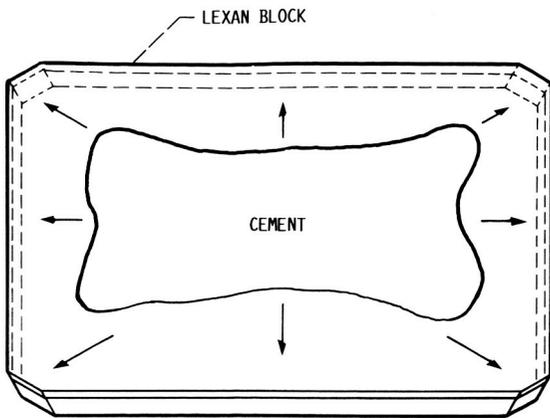
FIGURE 4. - SPREADING OF CEMENT.

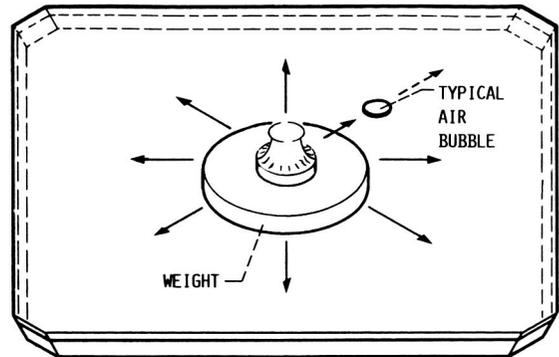
FIGURE 5. - BUBBLE MIGRATION.

Small bubbles often remained trapped between the surfaces. Usually they could be forced out by placing a weight between the center of the sample and the air bubble and moving the weight toward the nearest edge to follow the migrating bubble (fig. 5). It generally took about 1/2 hour to get an even spread of cement between the two surfaces and to remove all the air. The weight of the sapphire material forced excess cement from between the two surfaces. When the cement stopped seeping out and the excess had been removed from the edges, the sandwich was placed into the holding fixture. The fixture prevented the sapphire from sliding around on the cement before it became tacky (fig. 6). The sandwiched materials were then exposed to long-wave ultraviolet light for 10 minutes to set the sample. The light source was a Pen-Ray model

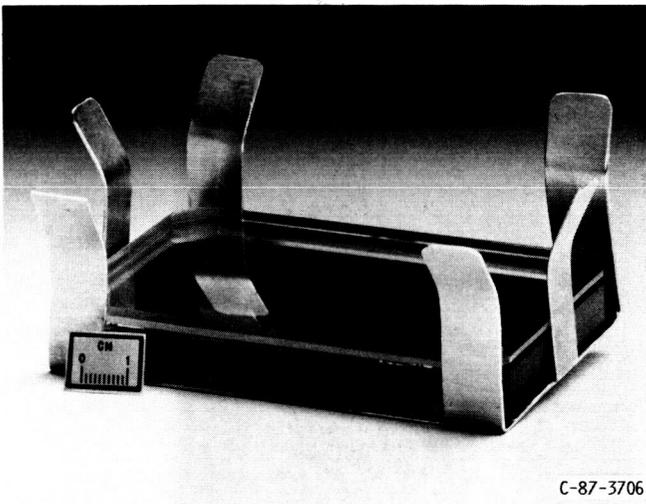
FIGURE 6. - HOLDING FIXTURE.

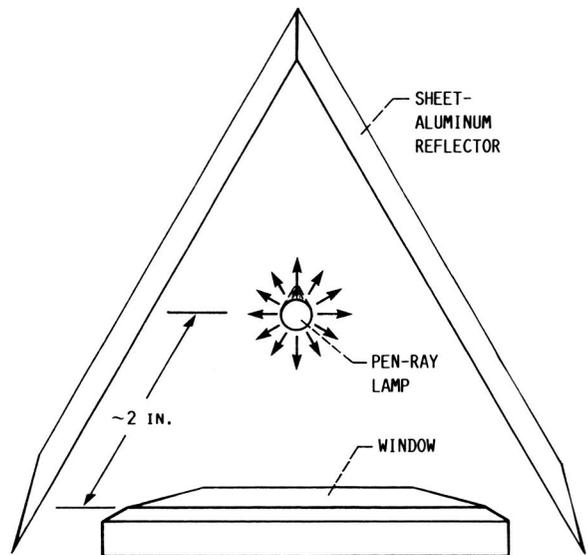
FIGURE 7. - CURING STATION.

SCT-1 placed approximately 2 inches from the sapphire surface. The window was cleaned, inspected, and then exposed to the lamp for 6 hours to cure. During exposure a reflector was placed over the lamp and the window to concentrate the light and to protect personnel (fig. 7).

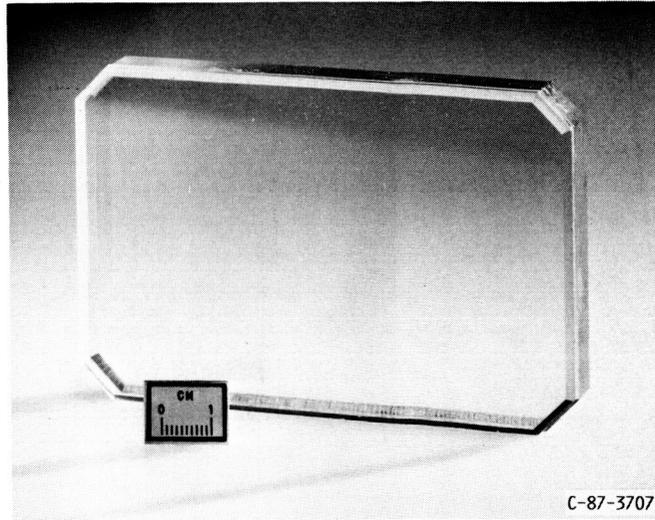
FIGURE 8. - COMPLETED LEXAN-SAPPHIRE WINDOW.

The completed windows (fig. 8) were installed in a pressure vessel (fig. 9) and hydrostatically tested to 60 psig. The pressure vessel was then pressurized with 2 atmospheres of helium and placed in a vacuum chamber evacuated to 10^{-5} torr. A leak check was conducted.

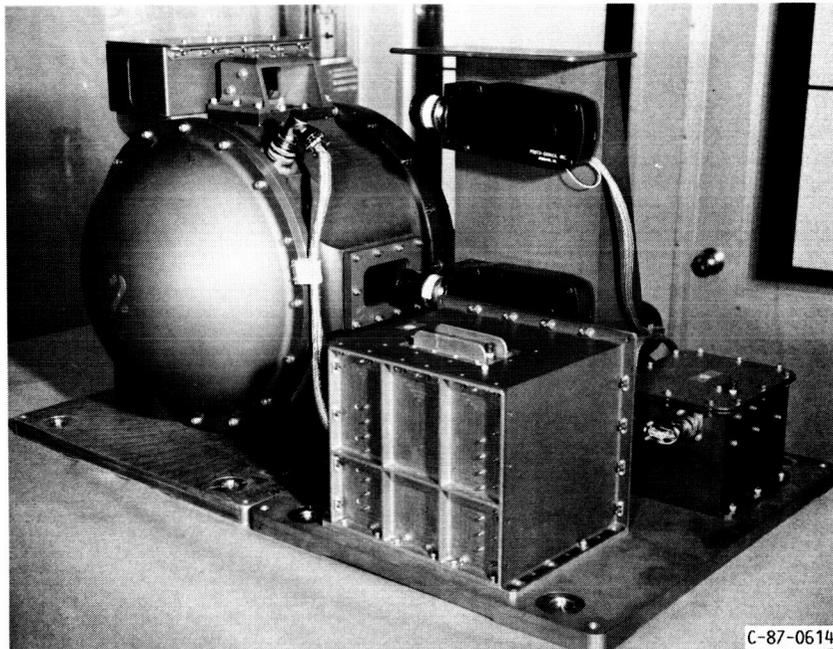
FIGURE 9. - PRESSURE VESSEL.
